Wind Turbine Slip Ring Repair

The three slip rings on a 480 Volt, 28 Amp Westinghouse WWG-0600 Wind Turbine Generator were repaired in-situ, approximately 100 feet above ground, with the portable SIFCO Process of selective (brush) plating.

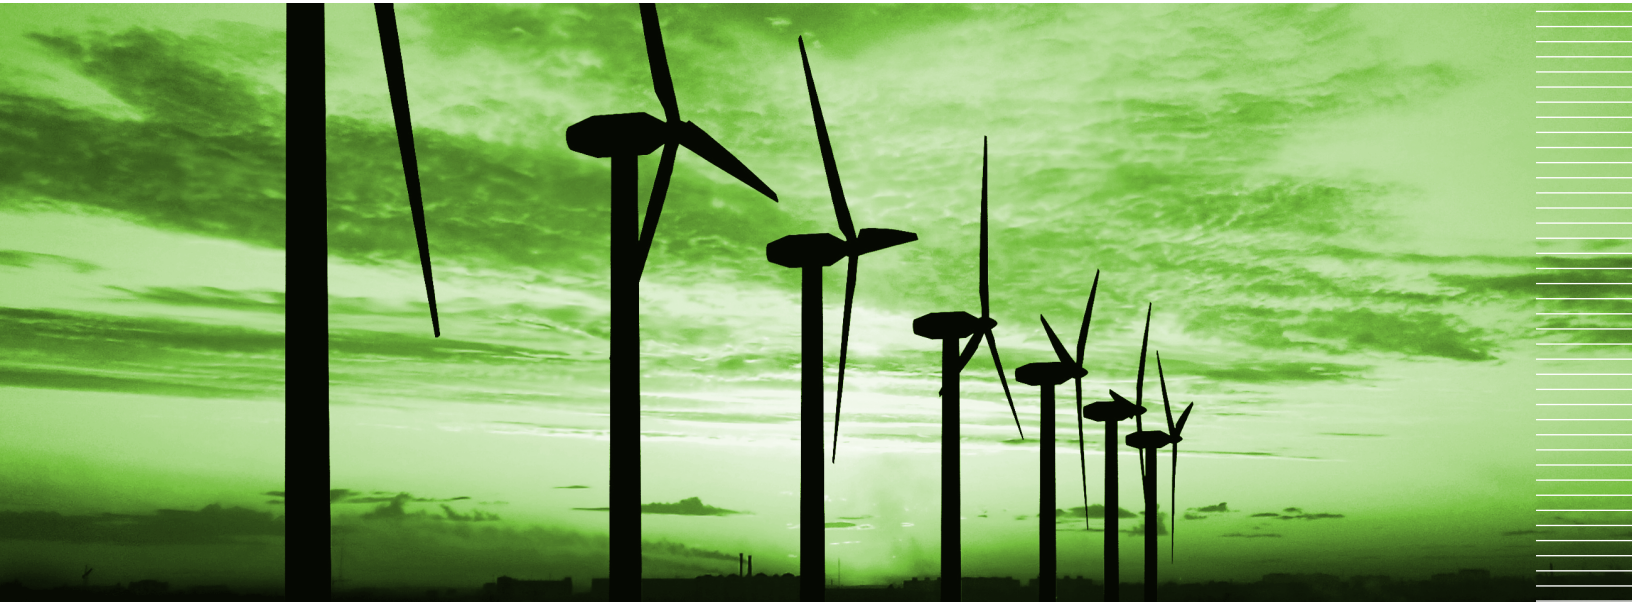
The three slip ring areas are 18" in diameter, 1/4" wide and approximately 1/4" deep. These OEM, copper based slip rings were molded together with epoxy to isolate them. The molded slip ring assembly was originally tank electroplated with 0.0015" silver. Premature failure occurred as graphite contacts eroded the silver. The contacts caused the silver to be "ground" into a dust, which when combined with the light lube coating created an abrasive paste that completely wore through the silver and into the copper substrate.

These photographs show how the slip rings on the wind turbine were repaired in place. A thickness of 0.030" of copper was brush plated to resize the worn diameters. The grooves were then dressed back with a standard file and sandpaper until plan dimensions were achieved. After dressing the plated copper deposit, 0.003" thick layer of silver was then brush plated for improved conductivity.
