## On-Site Pinion Gear Repair

Horsburgh & Scott

Repairing the pinion gear of a mining crane in-situ

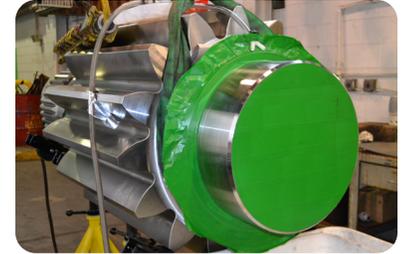
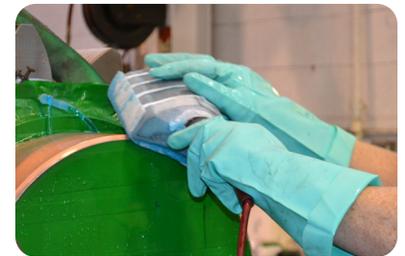
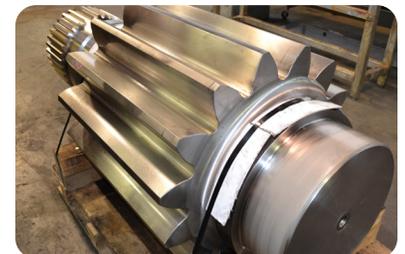
The bearing journal in question had incurred a deep gouge measuring 0.030" in depth, 0.75" wide and 12" long making it 0.012" undersize.

The groove was relatively shallow therefore could be quickly filled with copper using a 100% tool contact. The bearing journal was first plated with 0.001" thickness of copper and then masked for the defect repair. The anode that was then used to fill the defect covered the full length of the gouge. The gouge was filled with three layers of copper and hand finished in between. The final layer was then dressed flush by the SIFCO ASC technician and once the defect was repaired, the Outside Diameter was plated with 0.006" thickness of nickel using an ID plater.
